WSDOT/WASHINGTON STATE FERRIES

**Investigation into the Circumstances Surrounding the
Damage to the Propulsion Drive Motor aboard the
M/V WALLA WALLA on Nov. 4, 2012 while
Undergoing Maintenance at Eagle Harbor
Maintenance Facility**

WSF Investigation Panel

2/25/2013

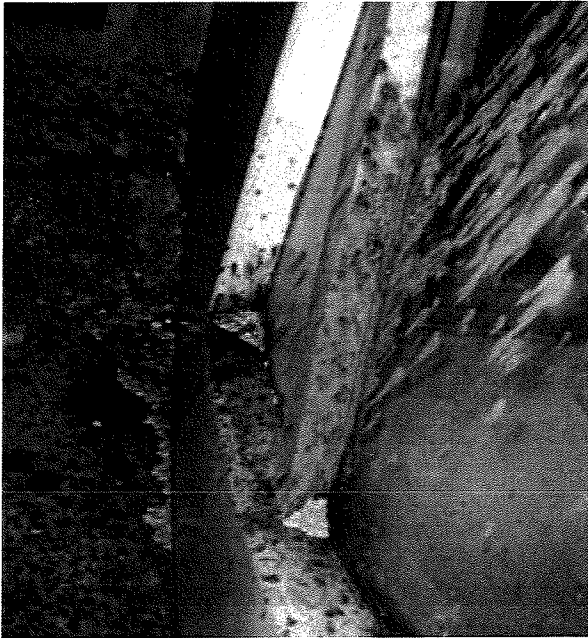
Molten and spattered copper from Commutator bars in Drive Motor housing

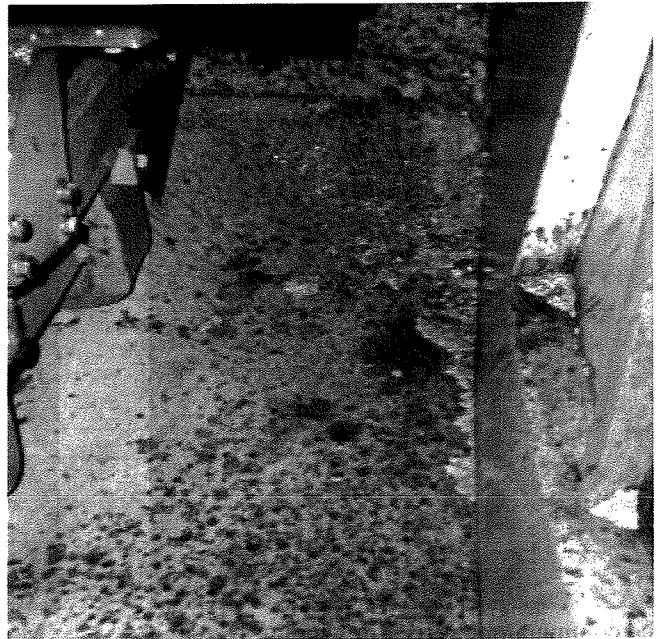
Molten and spattered copper from Commutator bars in Drive Motor housing

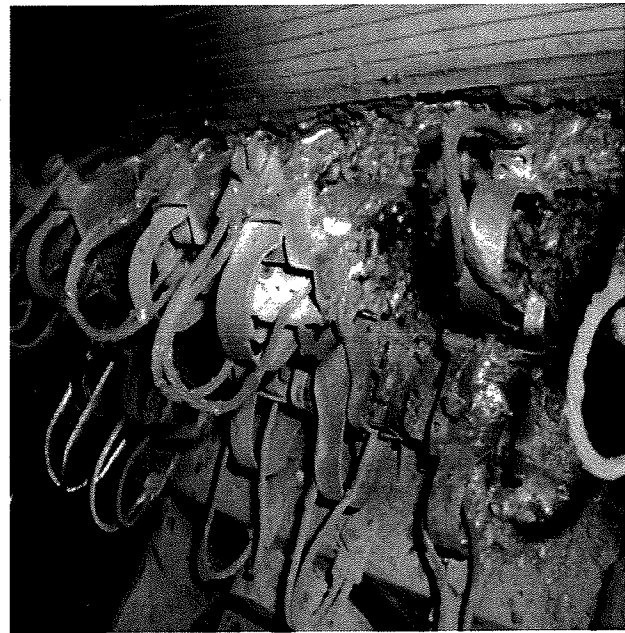
Damaged carbon brushes, brush pigtails, brush holders, and commutator bars

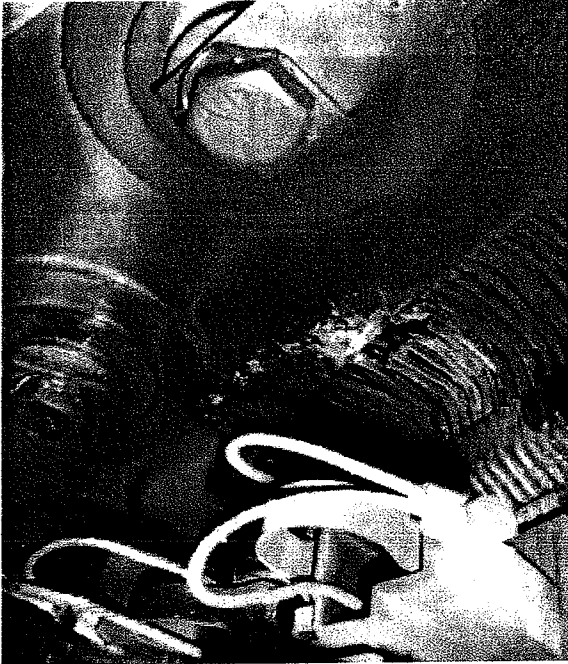
Burned commutator bar riser to winding connections

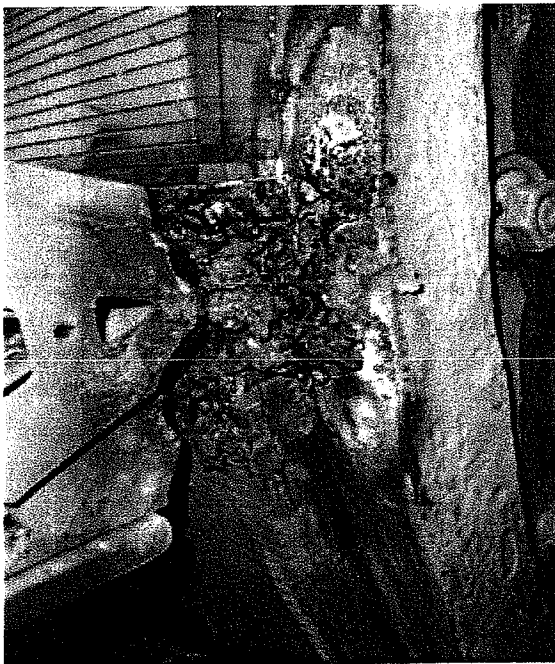
Extensive damage to brush and commutator bars

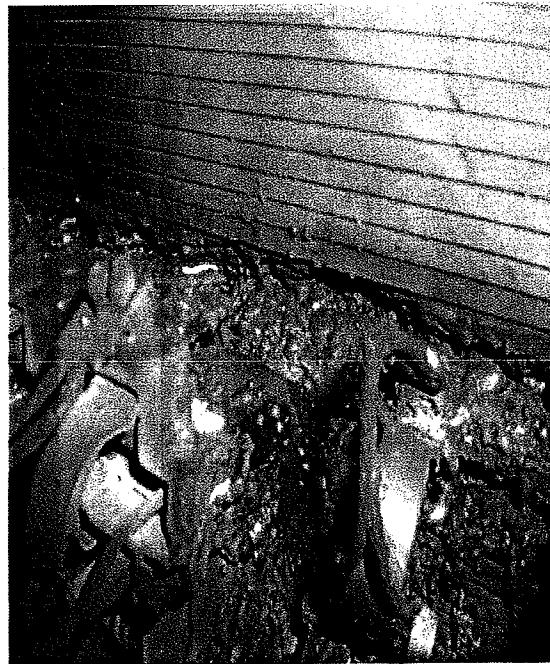
Extensive damage to brush and commutator bar

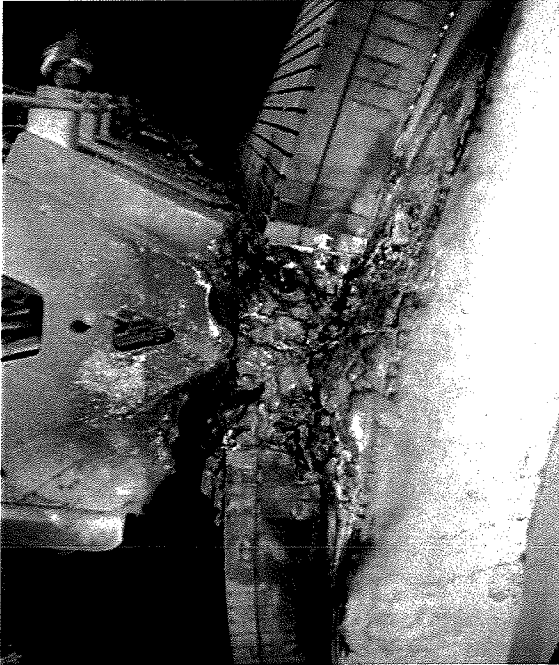
End on view of extensive damage to brush and commutator bars

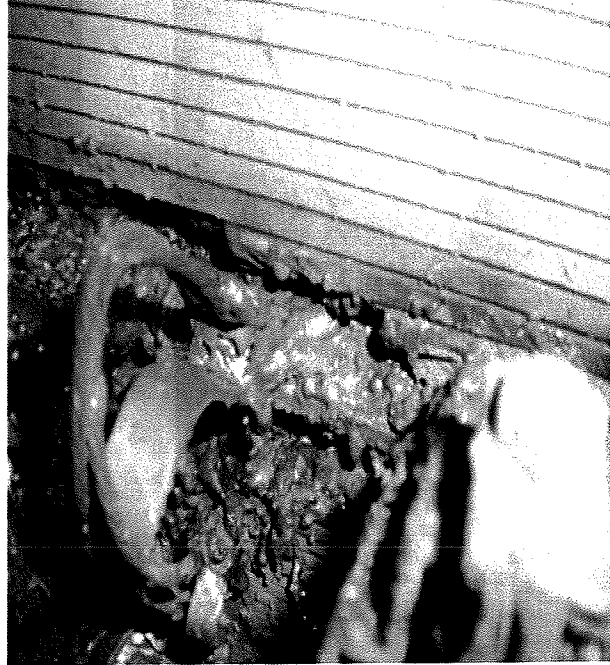
Extensive damage to brush and commutator bars

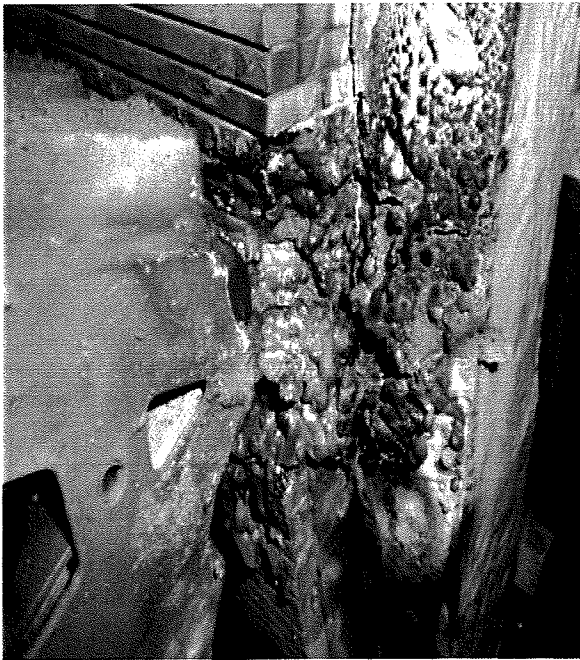
Extensive damage to brush and commutator bars

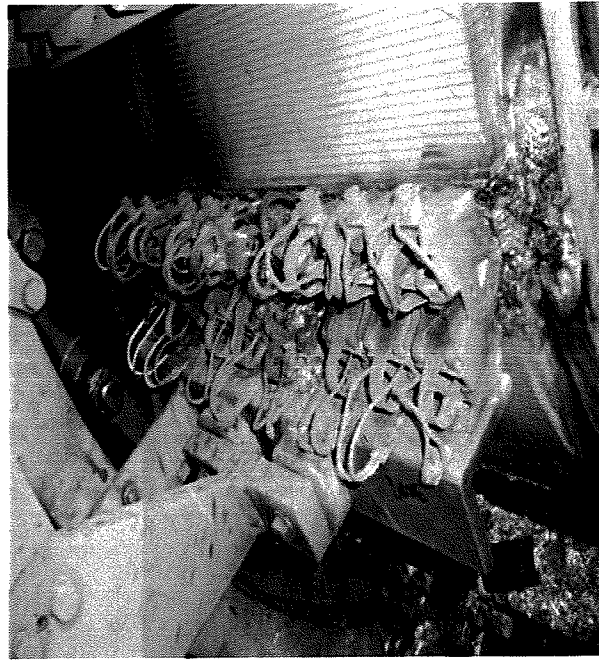
Overall view of the row of brushes that overheated arced, and caused the extensive damage to brush and commutator bars

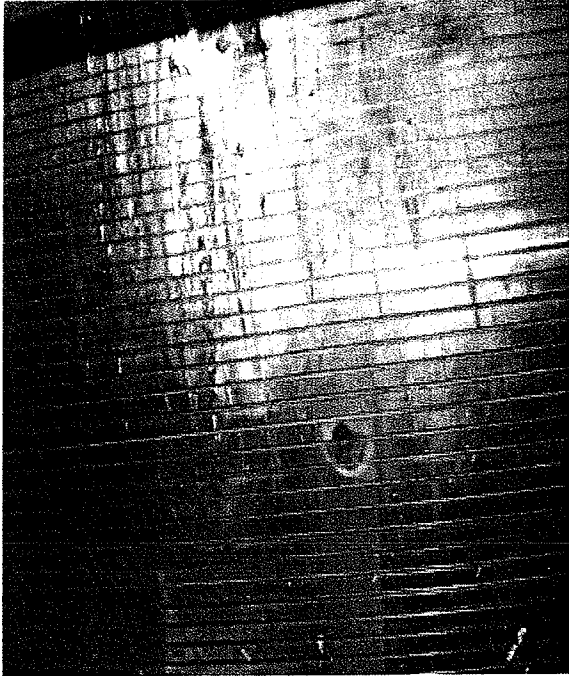
Commutator bars adjacent to the severely damaged area, showing signs of spattered, molten copper

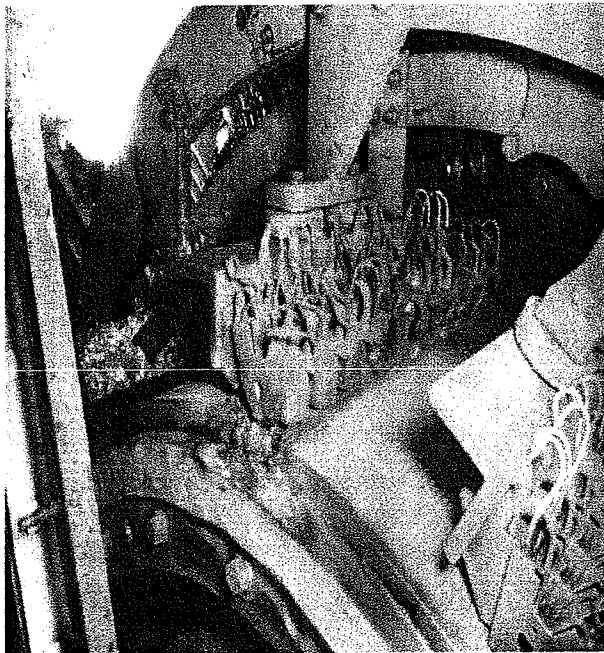
Overall view of the row of brushes that overheated and caused the extensive damage to brush and commutator bars

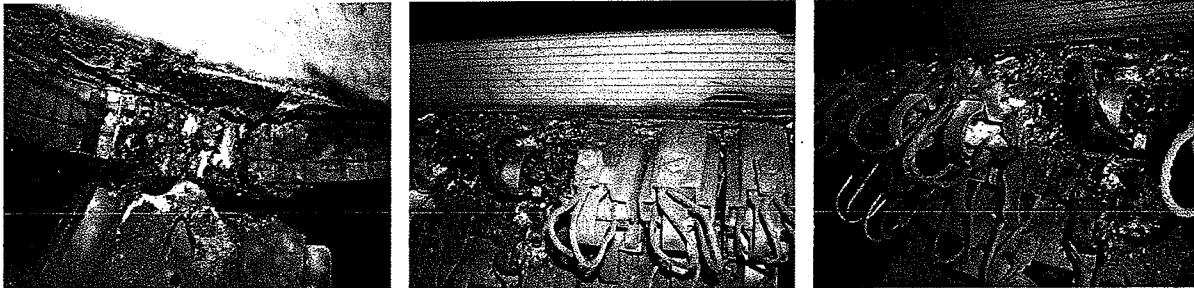
Figures 1-3

On November 4, 2012, the vessel Walla Walla was moored at Eagle Harbor Maintenance facility, undergoing propulsion system maintenance. The 1A propulsion motor suffered severe overheating and damage to its armature (see Figures 1, 2, and 3). This incident happened due to a breakdown in communication between the maintenance crew and vessel engineers, lack of system understanding and written procedures and an overly ambitious schedule, attempting to accomplish more than reasonably possible.

The 1A motor was scheduled to have maintenance done after the 2B stoning procedure was completed. Because two sets of brushes were left in their operational position, voltage was applied to the armature through the brushes while the A propulsion loop was energized and caused significant heat damage.

The Plexiglas covers were all in place on the 1A motor during this incident, containing all arcing that occurred. Because the covers were in place, it eliminated any safety concerns regarding adjacent equipment or personnel. There were no individuals in that space during this maintenance.

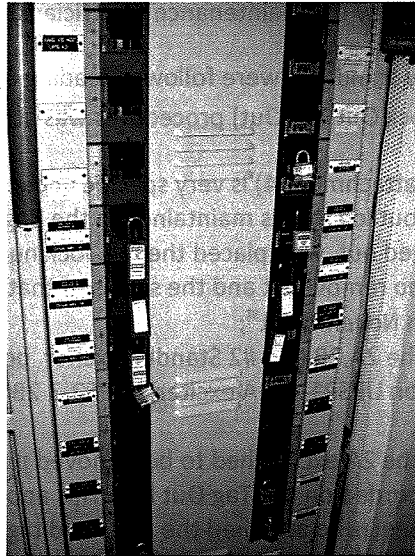
Figure 3

The electricians assumed that with the excitation deenergized and tagged/locked out, the 1A motor which is also part of the A loop, would be OK while still in that loop.

The Staff Chief Engineer, Bruce Cooper, opened all the switches for the 1A & 1B motor exciters, tagged and locked out the power to the exciter cabinets for the 1A & 1B motors; see Figure 3.
